**PHASE I ENVIRONMENTAL SITE ASSESSMENT  
SILVER BAY LOGGING  
121 THROUGH 165 S. RIVER STREET <sup>(1)</sup>  
SEATTLE, WASHINGTON**

Port of Seattle Engineering Department  
Seattle, Washington

Onsite Enterprises, Inc.  
6605 - 146 Avenue NE  
Redmond, Washington

January 1998

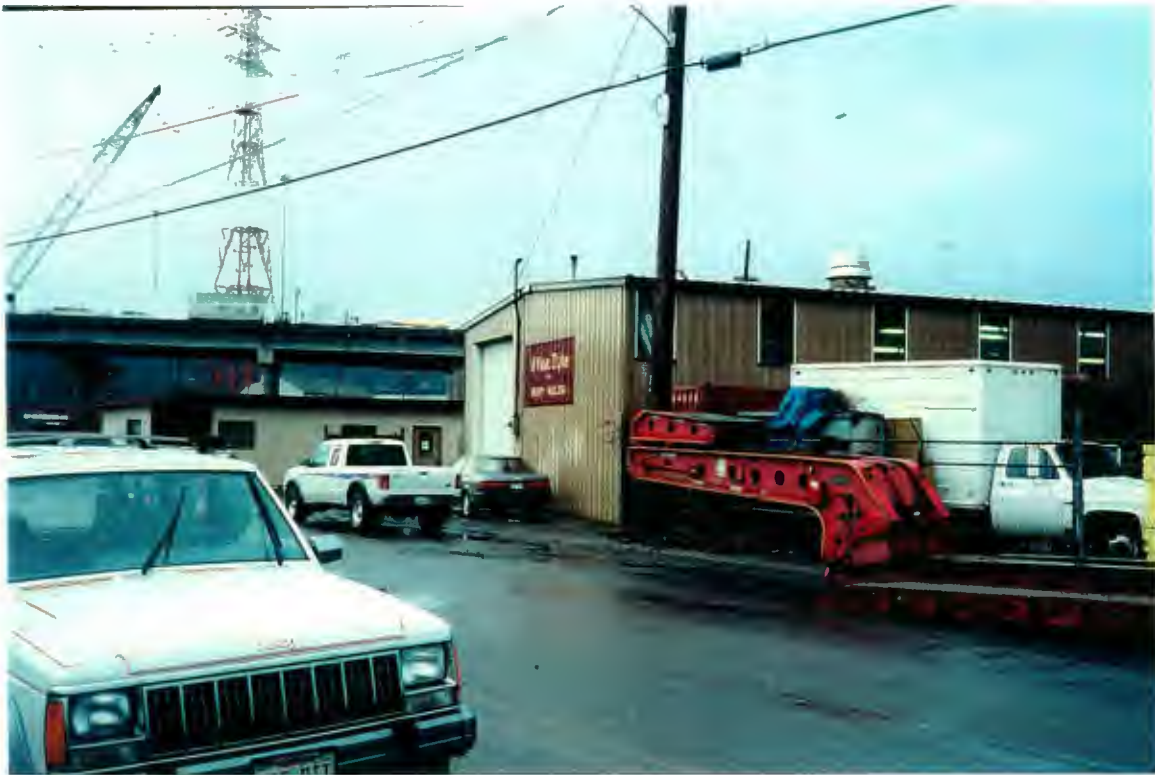
1

V Van Dyke Inc. - 150 S. River Street: A view of this property can be seen in Appendix A, Photo No. 1. Detailed information in the Site Assessment Report (Appendix C - page 14) indicates the site contained four (4) USTs which were removed. Tank contents are listed as unleaded gas, used oil, waste oil and other. No data is available regarding leak monitoring. One tank reportedly contained 1,100 gallons. Since the site is likely to be immediately upgradient of the subject property, there is a possibility that releases of petroleum products to the shallow groundwater table could have migrated under River Street toward the subject property. However, no leak has been reported and the site is not included on the State's LUST listing.

Observation of adjacent and adjoining properties revealed the proximity of the V. Van Dyke property at the north side of S. River Street (Appendix A, photograph No 1). This site formerly contained four underground storage tanks that were removed. However, there is no documented or observed evidence of any contaminant migration from the V. Van Dyke site. Also, there is some potential for petroleum contamination on the adjoining parcel immediately east of the site (fuel dock access; an above-ground storage tank and several drums were observed on the property. However, access to that site was not available for closer inspection. It is possible some petroleum contamination could migrate onto the subject property.

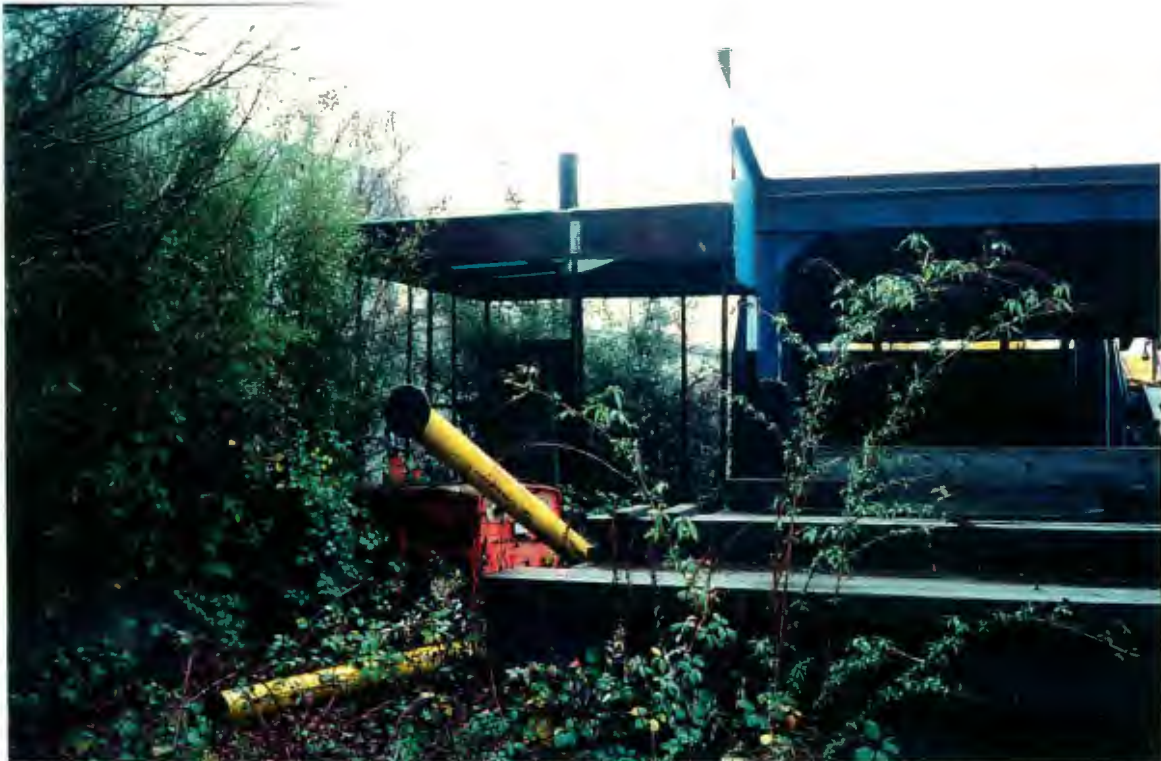
6

An old portable generator was observed in the brush at the east side of the property (Appendix A, Photo No. 6). This unit could still contain fuel, although this could not be confirmed. A old tugboat with rotting hull is present in the open yard area east of the building at 121 S. River Street; there is a potential for hull paint (possible metals) to be dispersed into the surface soil at this location (Appendix A, photo No. 25). A metal sink was observed attached to the exterior portion of the metal-frame building comprising Section A at 121 S. River Street. There are no drain pipes

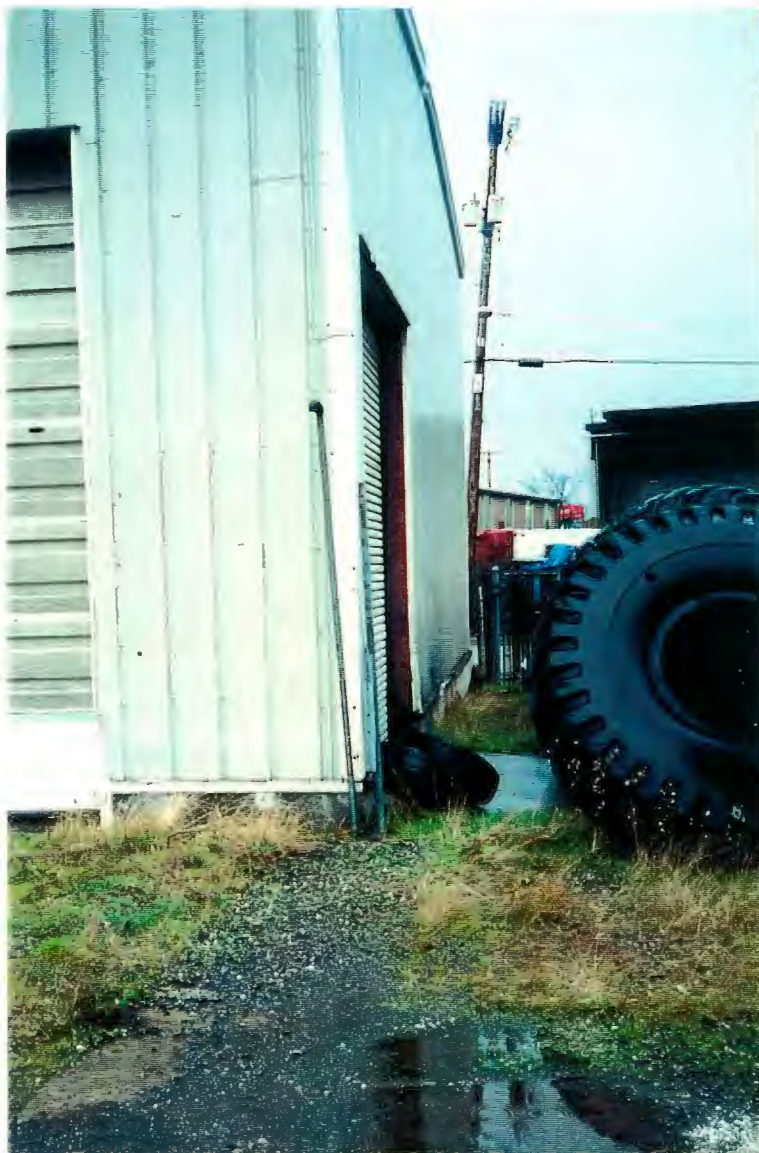
16

The location of one potential underground storage tank was observed at the southeast corner of the metal-frame building at 129 S. River Street. A possible vent pipe was observed at this location (Appendix A, photograph No. 16).

Items 1 through 6 should be evaluated further (Phase II evaluation) using established exploratory or testing methods to determine if UST's are present, and to check for potential soil contaminants and other regulated materials listed above that may be present on site. If UST's are determined to be present at the site, then appropriate measures should be taken to report their presence to the State (Department of Ecology), remove them and check for any releases of petroleum products that may be attributed to past or present leakage. The containers of regulated materials are confirmed as being present on site, but will likely be removed by the current tenants. One exception may be the materials observed in the metal-frame building at 129 S. River Street which is presently unoccupied. Sediment contamination in the adjacent Slip No. 3 is a concern to the extent ownership of the subject parcels extends into submerged lands as so indicated in the legal description.

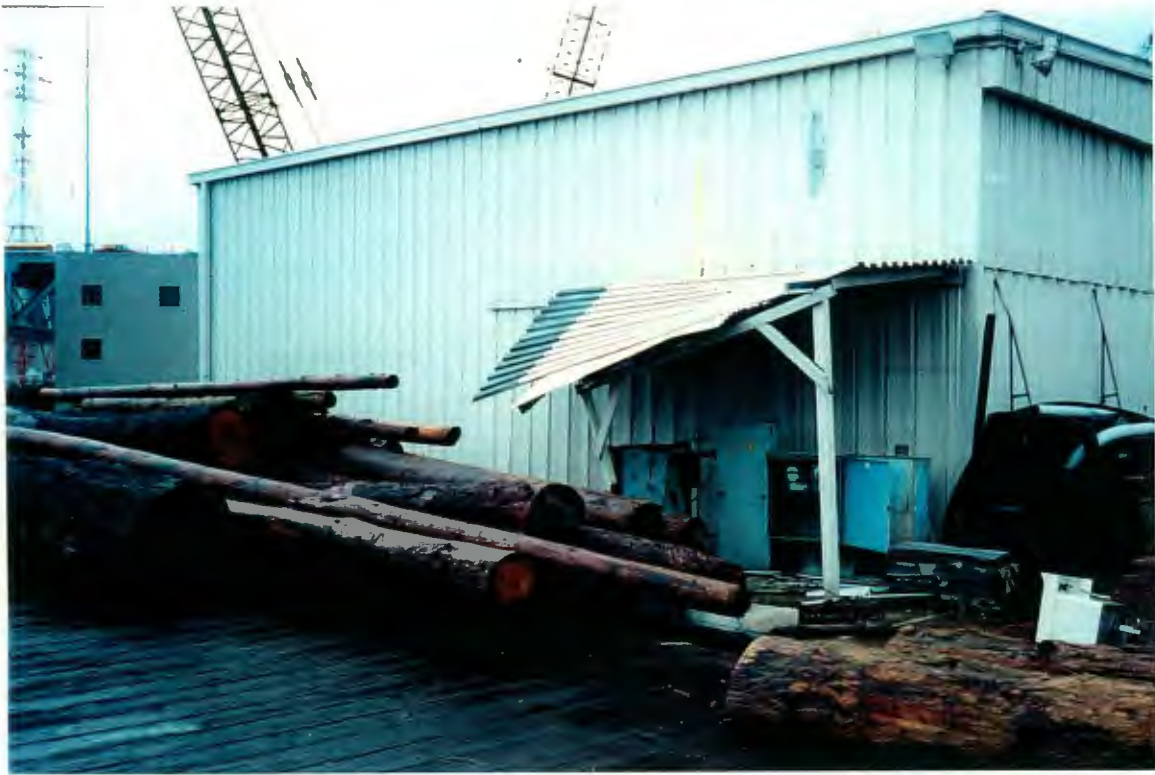
21

21.	Exterior of South side of 121 S. River. Note electrical service (no wet transformers observed) Logs are on west end of dock.
22.	Exterior of east side of 122 S. River - Section B. Trench drain in area flows south to catch basin in foreground. Reddish material on ground is wet sawdust.

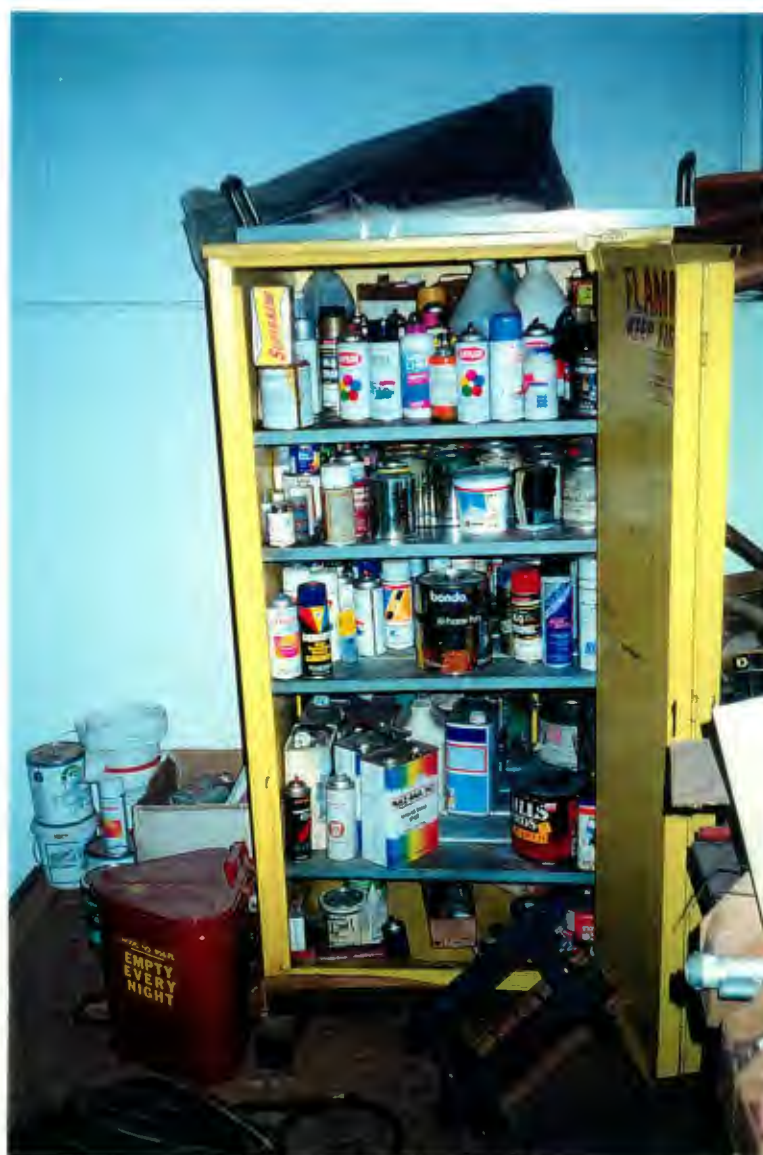
36

The center rear of the storage area is occupied by an enclosed machine shop. The room contains a lathe and drill press. Slight oil staining was observed on the concrete floor beneath the drill press, but this is minor and the shop is generally clean. Some small cans of paint were also observed in machine shop area. Storage on top of the machine shop enclosure (Appendix A, photos 33 through 35) included a flammables locker containing a large inventory of small paint cans and miscellaneous solvents (Appendix A, photo No. 36).

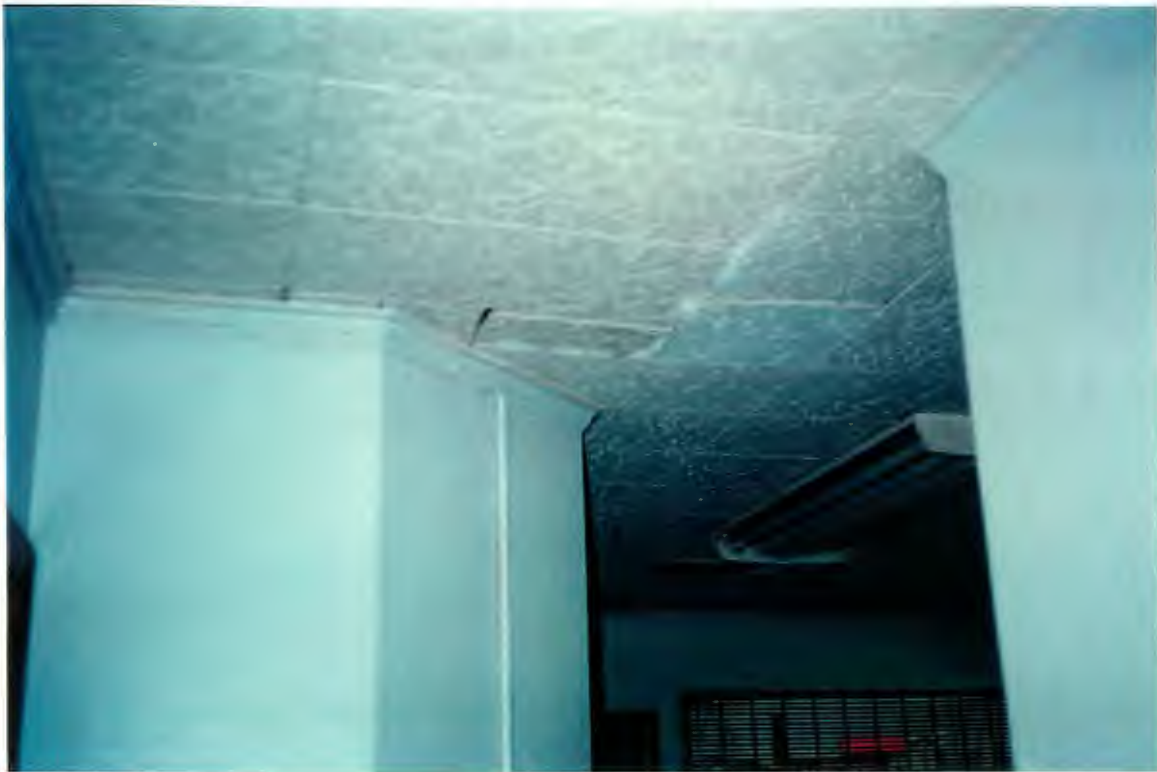
39

The adjoining office areas were observed. Potential ACM acoustical ceiling tile was observed in the office and hall areas (Appendix A, photo No. 39).

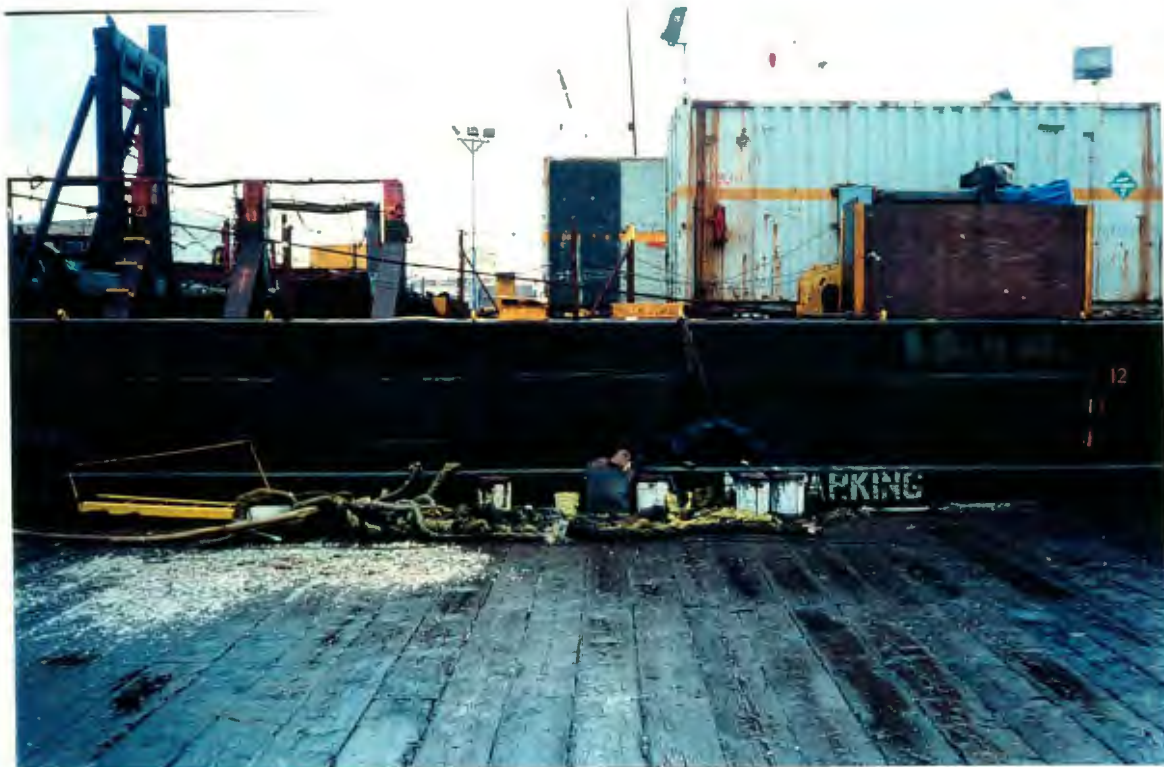
40

40. Cans of tar material at south (seaward) edge of dock at south side of property. White material on dock is broken barnacle shell residue.
41. Dock at south shore of property, looking east (SCS Cold Storage in background) note crane on dock. Dock surface appeared clean and free of oily sheens. Wood dock is constructed of treated (creosote) wood, but is fairly weathered.

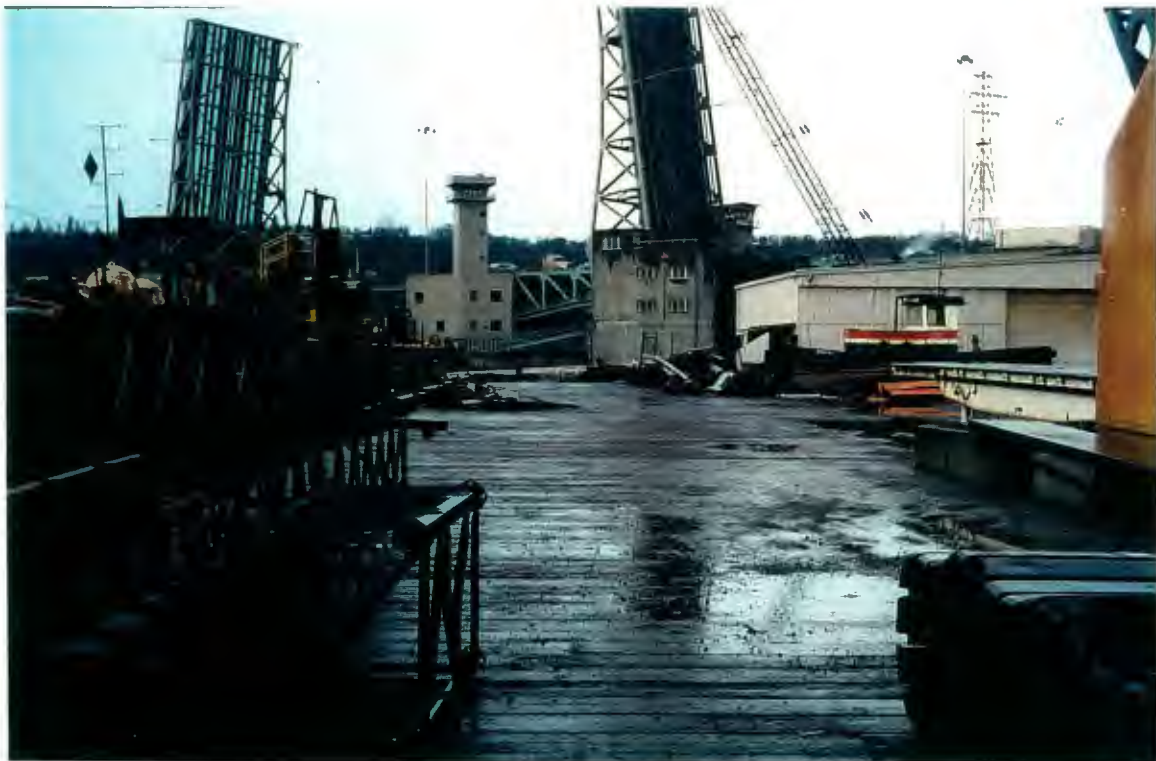
42

42. Dock at south shore of property looking west. Crane shown in photo 41 is at extreme right.
